Final Report for Period: 10/2001 - 09/2002

Principal Investigator: Astaneh-Asl, Abolhassan .

World Trade Center Post-Disaster Reconnaissance and Perishable Structural Engineering Data Collection

Field Investigation and Analyses of the Collapse of the World Trade Center

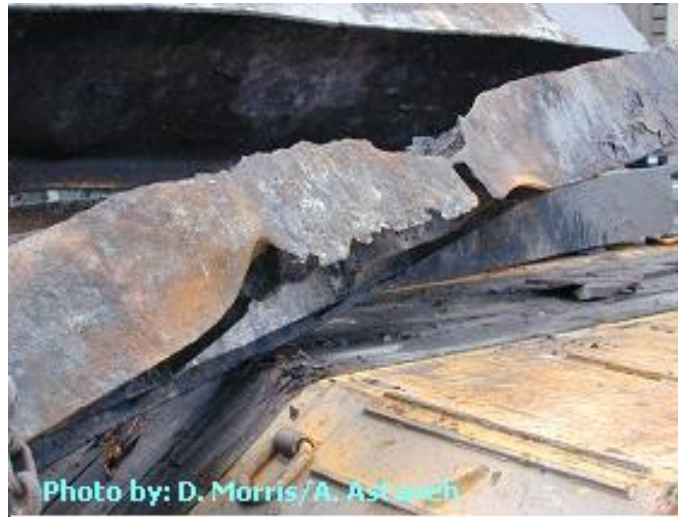
The first part of investigation involved inspection of steel being removed from ground zero. Most of this steel was from Building 7 of the World Trade Center. Building 7, a 47-story steel structure, caught fire apparently after being hit by the falling debris from the towers and was burning for more than seven hours before collapsing in the afternoon of September 11. Figure 10 shows an example of steel removed from the site of the collapsed Building 7. The inspection of steel indicated that there was very intense fire inside the building. Fortunately, since this building was evacuated after the planes have hit the towers, no lives were reported lost in this building. The exact cause of collapse of this structure has not been established. According to press reports, this building apparently had a large emergency fuel tank that may have contributed to intensity of the fire in this building.

Figure 10. A Beam Removed From the World Trade Center the Site Most Probably From Building 7 (Ref: Astaneh-Asl, 2002b)

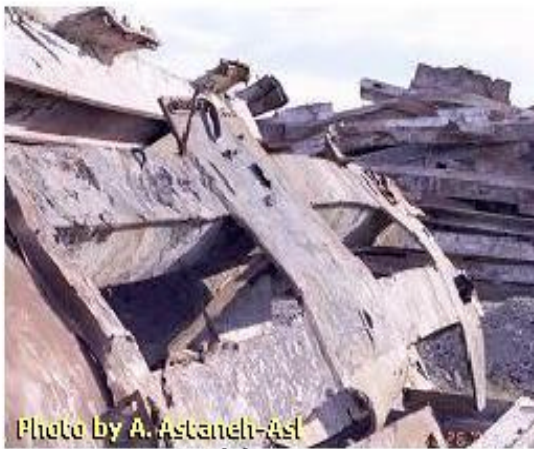
Figure 11 shows typical views of various components of the World Trade Center Towers after collapse. Figures 11(a) shows a view of one of the pre-fabricated units of the exterior tube. This unit appeared to be bent in a way that it may have been buckled while under the load instead of being bent due to drop from the height. The surface of this piece also appeared to clearly indicate exposure to intense and uniform fire throughout the clear length of column. In addition, there was no visible dent or damage that would indicate the bending might have been the result of other members falling on this particular member. Considering all these issues, which could be established by close and careful examination of structural pieces, one could reasonably conclude that this particular piece may have been damaged while the structure was still standing. This distinction is very important since if further identification of the piece indicate that indeed this piece may have been in a location that could have been subjected to intense fire, then by testing this element many valuable pieces of data could be gathered. There were a number of other pieces such as these that the author was able to identify as possibly important pieces and keep for further investigation.

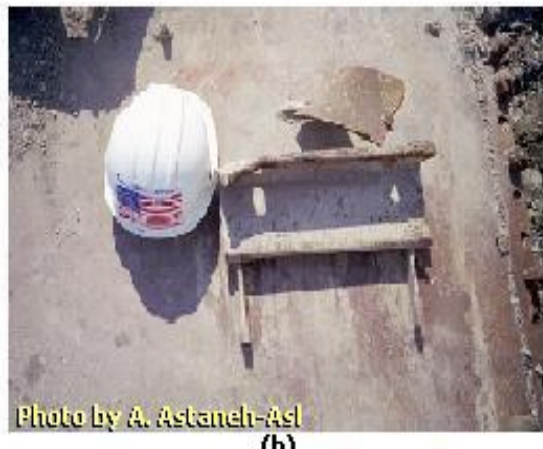
Figure 11(b) shows typical appearance of the seat angles supporting the floor double joists. The seat angle supports were on the every-other exterior columns. In general most seat angles that were inspected had their outstanding legs bent downward possibly due to the impact of collapsing floors from above. In some cases, the seat angles were gone due to failure of welds connecting them to the two outstanding plates behind them.

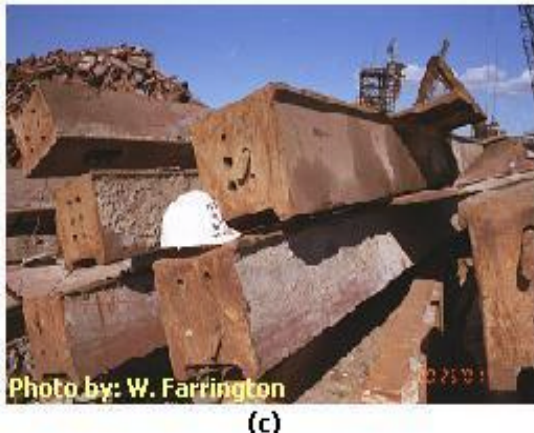
Figure 11(c) shows a view of the end plate splice connection of exterior box columns. In almost all cases that were inspected, The failure of splice was due to bolt failure in tension combined with bending.

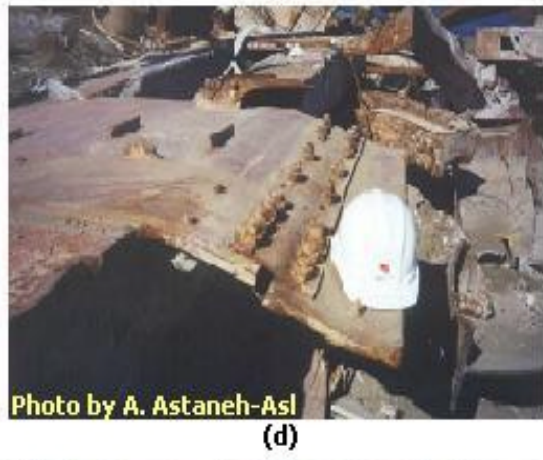
Figure 11(d) shows appearance of typical bolted double plate splices of the horizontal spandrel plates of the exterior tube.

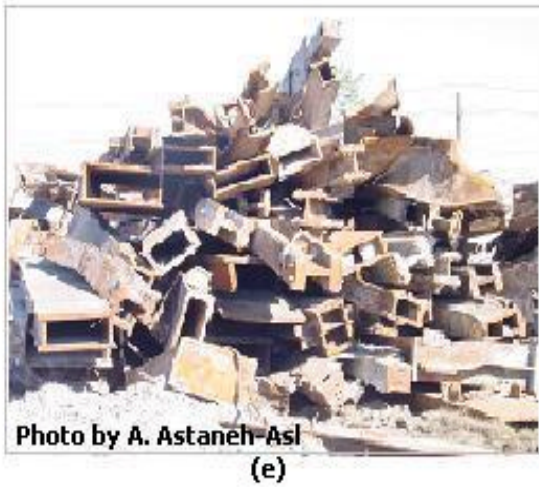
Figure 11(e) shows interior columns of the towers stacked on top of each other at recycling plant. Almost all interior column pieces that were inspected were intact and did not show failure of welds. As indicated earlier, these columns were gravity columns and their splices did not need to be designed for any amount of tension or bending. However, a

minimal splice was provided for these columns presumably for secondary forces and the forces during construction. Obviously, such minimal splices did not have a chance during the collapse stage to keep the columns together and had fractured. Observing the fact that the interior column splices were not needed and were so minimal, it is not clear if when the attacking Boeing 767 airplanes entered the towers any of the interior column were actually dislodged and eliminated or bent due to failure of their splices.

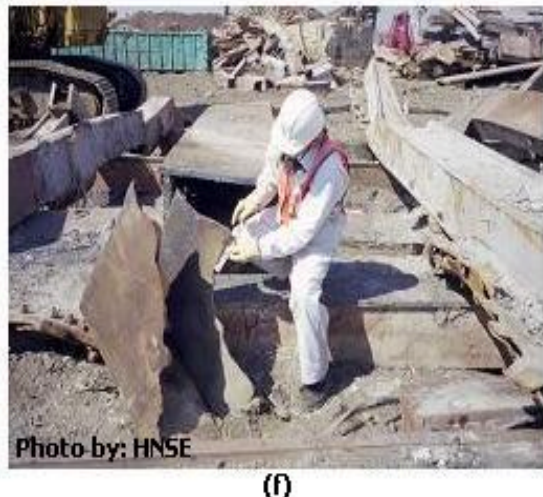
Figure 11(f) shows the author inspecting a piece of interior column that arose quite a lot of interest. The piece showed very clear signs of a large, round and fast moving object entering from the left side of the box and cutting a quarter of a circle hole in the column. It appeared at the time of its discovery among the steel at recycling plant that this column could be from the south tower. However, not having access to structural drawings at the time, it could not positively be identified as being at a floor level that could have been hit by the engine of the airliner entering the south tower. Further investigation of this piece can positively locate it and establish whether or not it is indeed hit by the airplane engine.

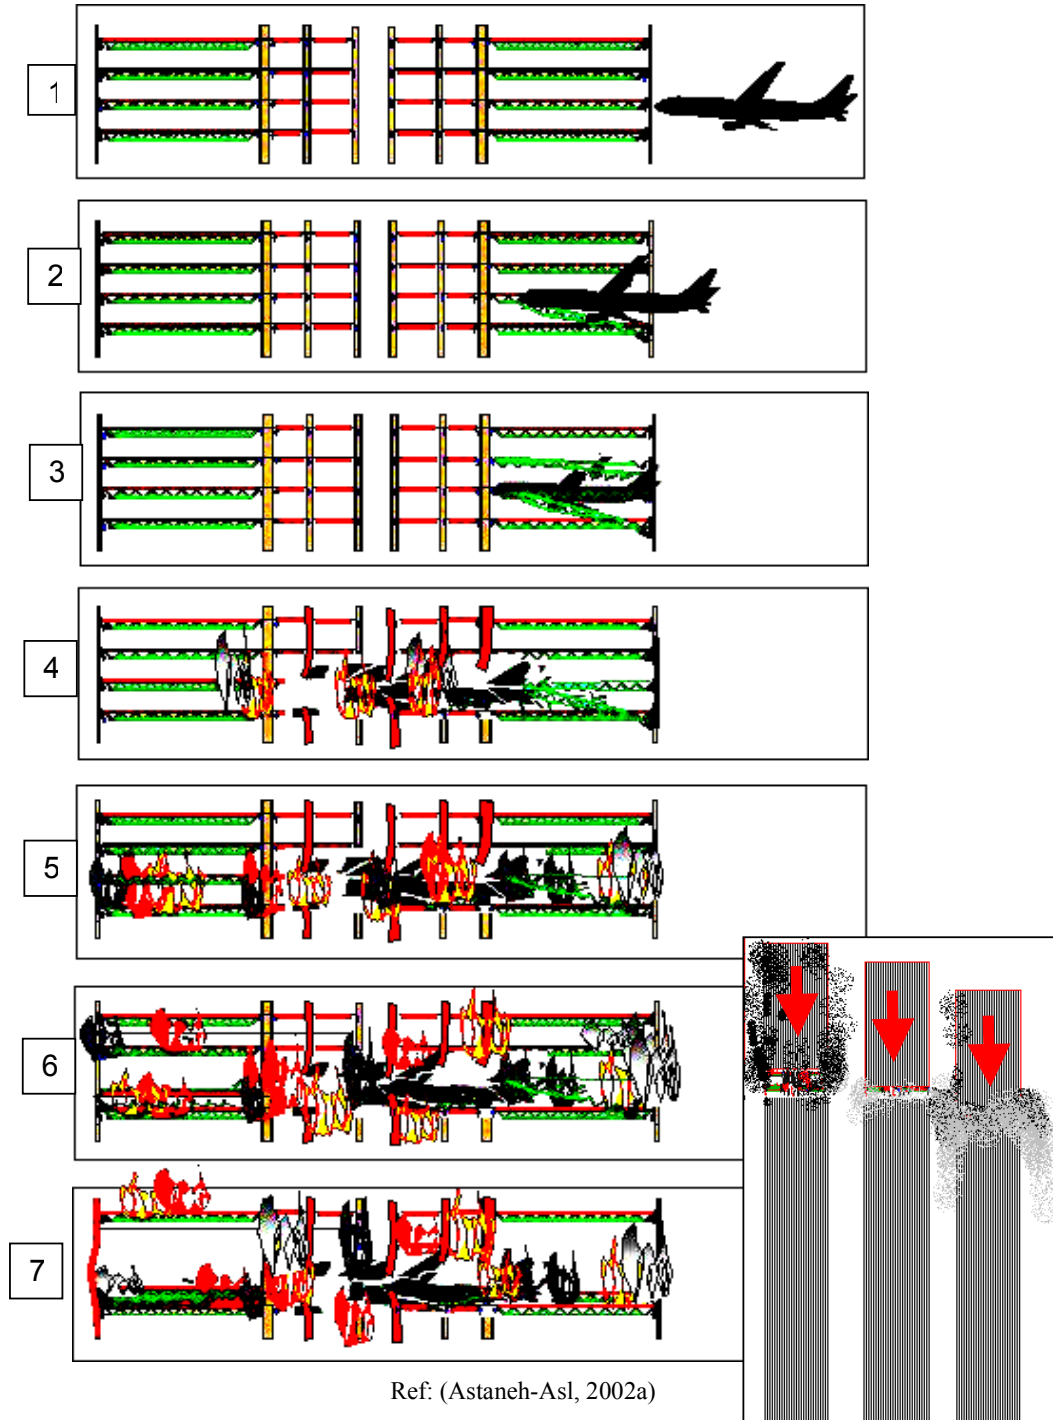
Figure 12. Sequence of Events in the Scenario of Collapse Proposed by A. Astaneh-Asl (2002a)

The author, at this writing, believes that a plausible scenario for the collapse of towers is as shown in Figure 12 and may have occurred in the following steps. The steps for both towers may have been:

1. The plane reached the tower and started impacting it.
2. The plane entered the building by cutting the relatively small but numerous box columns of the exterior tube. During this entry, it is believed that not much damage was done to the plane. However, the impact of the plane might have shaken the building, as indicated by the survivors, to cause separation of most of the sprayed-on fireproofing. Of course, due to large number of columns closely spaced on the perimeter to form the tube, the loss of columns that were severed by the planes did not cause the collapse and the towers were able to continue to stand up and carry its gravity load.

3. As the plane entered the tower, the floor system between the exterior tube and interior core in front of the plane was crushed and severely damaged. This is due to the fact that the floor system, as shown earlier, was made of floor truss joists and lightweight concrete. The author could not consider the trusses to be a match to the inertia of the entering plane and stand against the plane. However, the 10-14 cm horizontal floor slabs could have caused serious damage to the plane by cutting through it while getting crushed. It is possible that at this stage, the wings which contained the jet fuel, or part of the wings, might have severed and sprayed the jet fuel over large areas of three floors that were impacted by the plane. The fire may have started at this point.

4. The damaged plane, due to its inertia, continued to move forward and hit the core columns. These columns were generally much stronger than the outside columns and were able to better withstand the impact forces of the plane and inflict severe damage to the soft parts of the plane such as wings, tail and fuselage. Of course, those columns that were directly hit by the heavy and strong parts of the plane such as engines might have sustained serious damage and may have been severed. All these activities must have resulted in tearing apart the plane and spraying any remaining jet fuel inside the building. If the fire had not started earlier, these events at the core would have resulted in initiating the fire and spraying it throughout the floor. As indicated earlier, the core of the building had no heavy walls. All the walls in the core were drywalls (gypsum boards). The impact not only might have caused the collapse of these lightweight and relatively weak walls in the core, but also collapsed the floors and stairwells in the core. As reported in the press reports (Glanz and Lipton, 2002), all three stairwells in one tower and two of three in the second tower had collapsed cutting the egress routes for those who were trapped in the floors above the impact floors.

5. As the fire continued, the main structural elements: the exterior tube columns, the floor truss joists and the core columns and beams were subjected to fire due to burning jet fuel and the contents. As the fires burned, the strength of steel and its modulus of elasticity continued to decrease with increasing temperatures. The author believes that the first element to lose enough strength to collapse may have been the floor joists. These joists not only may have lost their fireproofing but also were heavily damaged due to entry and impact of the plane.

6. The collapse of truss joists may have resulted in doubling the buckling length of the exterior columns thus reducing their compressive capacity to one-quarter of their original capacity. In the meantime, these exterior columns were exposed to intense fire themselves and their original strength might have decreased substantially.

7. With the collapse of floor joists even over a portion of the floor, the affected columns would have buckled and collapsed almost immediately after the loss of their bracing. The buckling of these columns might have resulted in the load shifted to nearby columns and in fast moving domino effect collapse of all columns around the perimeter. Of course collapse of columns would have resulted in dropping of the upper portion of the structure on the lower portion as shown in Figure 12 and seen by millions throughout the world on September 11, 2001. The impact of the upper part dropping on the lower part caused the inevitable complete and vertical collapse of both towers under the acceleration of gravity.

3. There is a need for better fire protection for tall structures. The fire-proofing not only should be able to isolate the structural elements from the intense heat of fire, but the fireproofing needs to be strong enough or needs to be reinforced to stay on the element that it is protecting. Also, creating large office spaces, without partitioning walls, should be looked at carefully to ensure that such large spaces will not spread the fire throughout without walls stopping it.

5. There is a need to study and develop new concepts and systems that can tolerate the loss of several load-carrying members without full collapse in a progressive manner.
